NACA RM E55A21

ENGINE PERFORMANCE OF PRECISION-FORGED, ELECTROPOLISHED  
AND MACHINED BLADES OF NIMONIC 80 AND 80A ALLOYS

By Paul F. Sikora and James R. Johnston

Lewis Flight Propulsion Laboratory  
Cleveland, Ohio

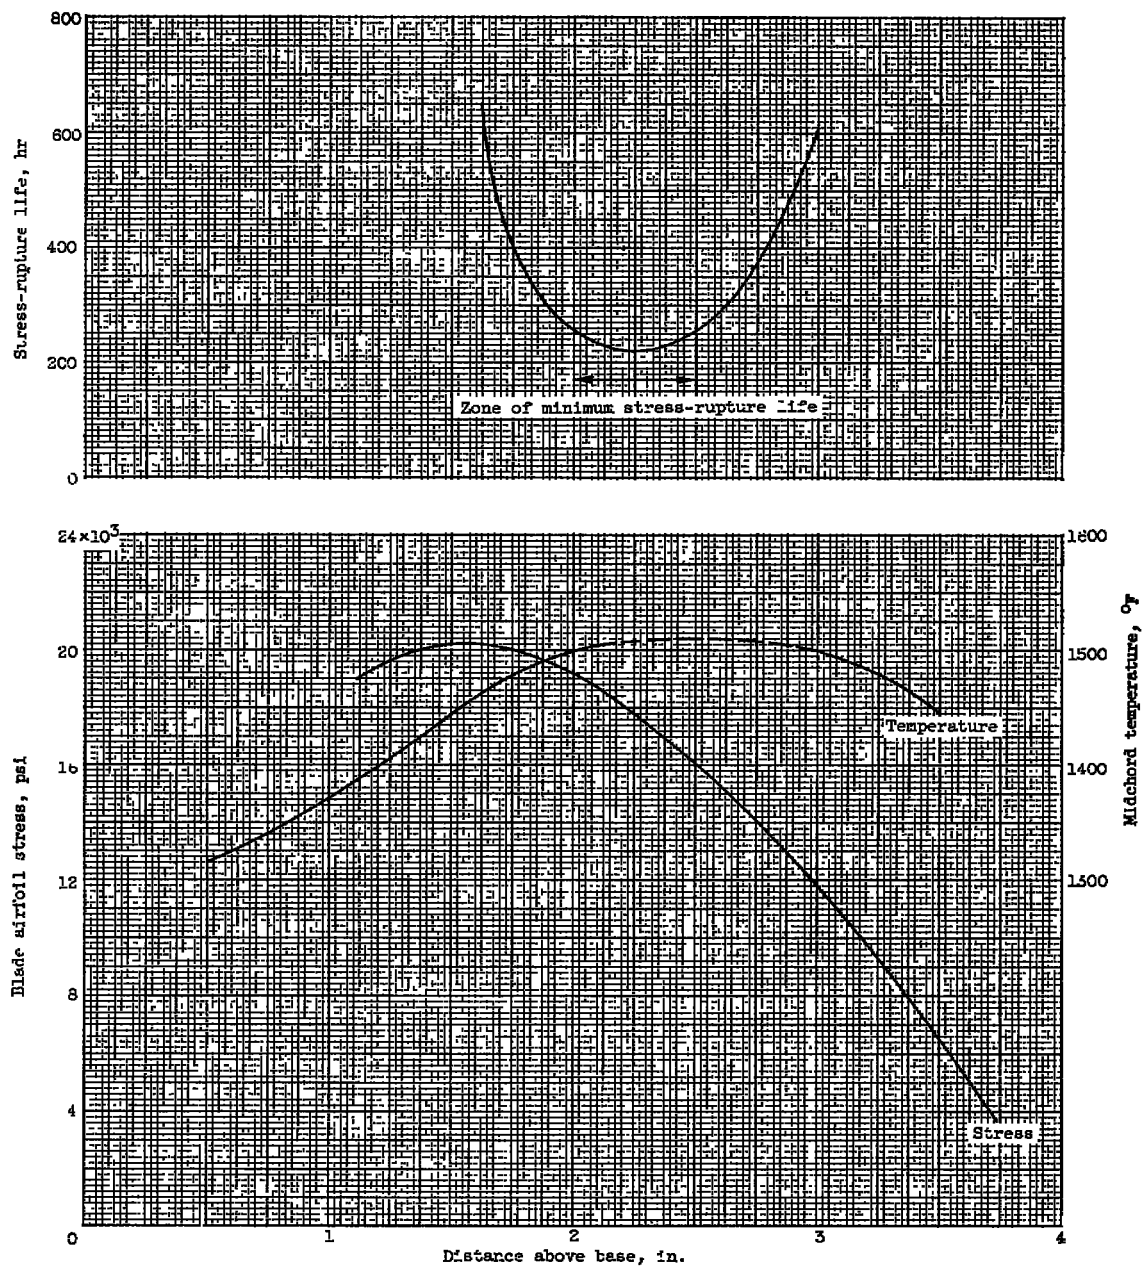
On the basis of the stress and temperature distribution, a plot of stress-rupture life was determined for the conditions at each increment of blade length as shown in figure 1. From this stress-rupture plot, it may be seen that a zone of the blade, if subjected to stress-rupture conditions alone, exists where the blade life should be a minimum. This zone lies between 2 and  $2\frac{1}{2}$  inches above the base.

approximately 18,000 pounds per square inch since the Nimonic 80 alloys are not sensitive to notches under these conditions (ref. 9). However, on the basis of the temperature distribution along the blade (fig. 1), there is a notch-sensitive region 1 to  $1\frac{1}{2}$  inches above the base. In this area of the blade, the temperature ranges from 1370° to 1450° F and the stress is approximately 20,000 pounds per square inch. In reference 9, it was shown that Nimonic 80A is notch-strengthened in rupture tests at 1200° F for times to rupture up to 1000 hours, and that at 1500° F no notch weakening should be observed at any time to rupture over 5 hours. In contrast, at 1300° and 1400° F pronounced notch weakening is observed at rupture times over 100 hours.

Figure 1. - Typical stress and temperature distribution of airfoil of J33-9 turbine blade of Nimonic 80 alloy.

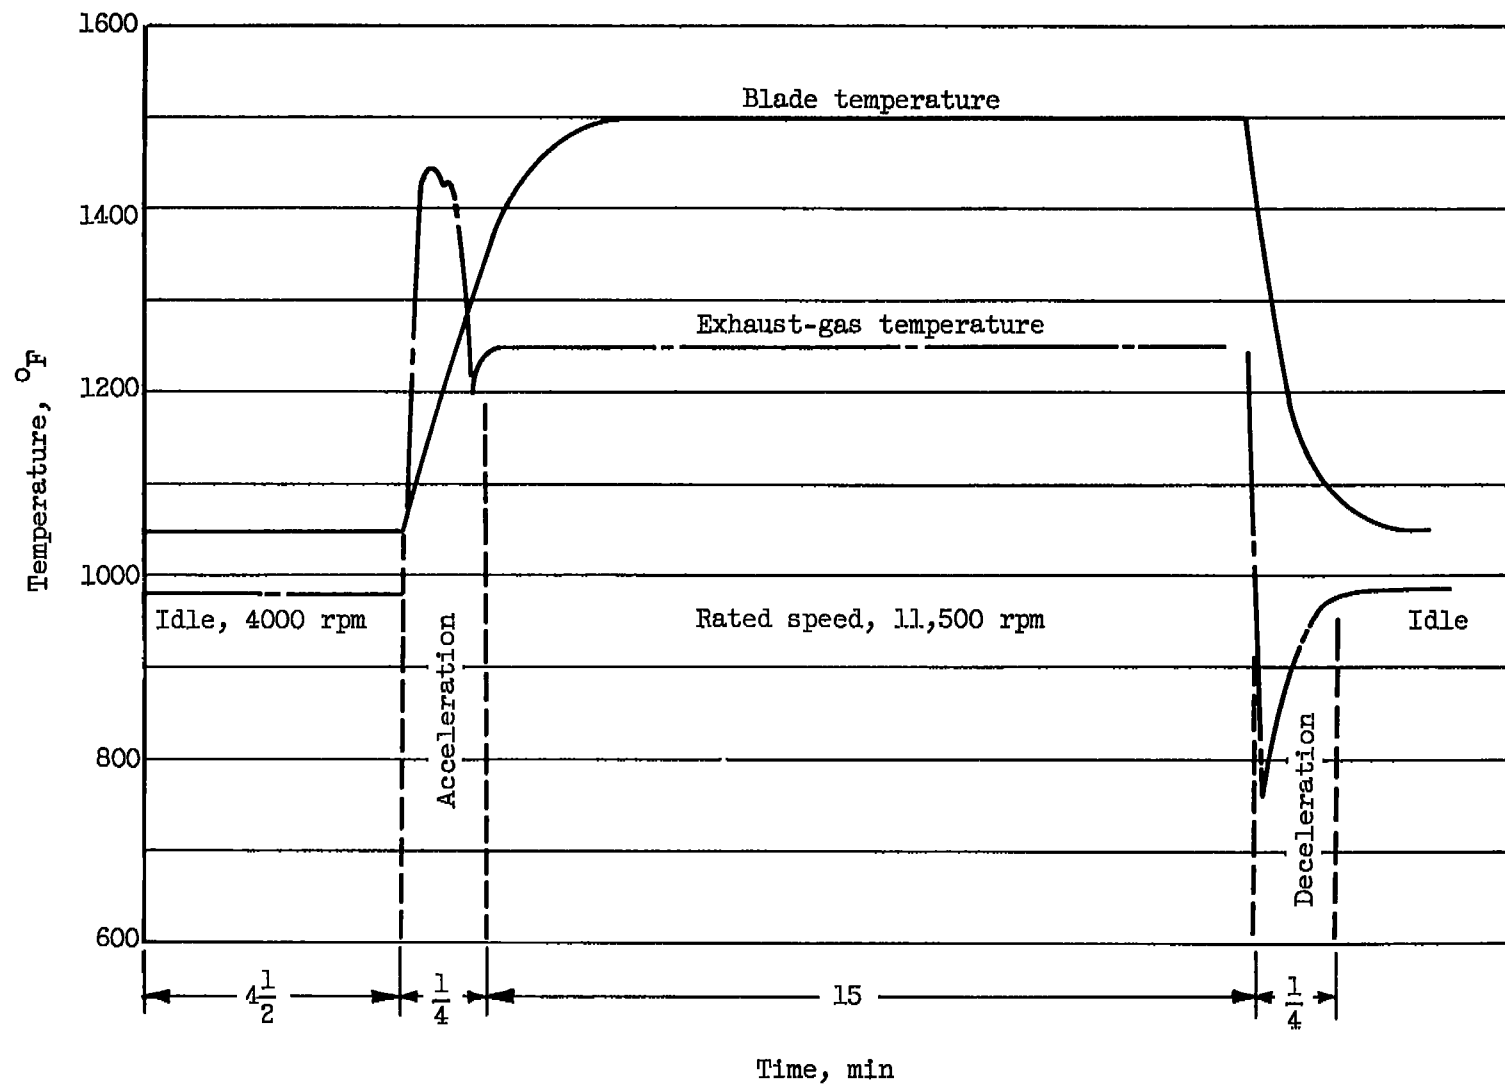
The test blades were installed in a J33-9 turbojet engine having a nominal thrust of 4000 pounds and employing a dual-entry centrifugal compressor. The engine and test instrumentation is described in reference 7. The engine test consisted of a repetition of the cycle shown in figure 2. During the rated-speed portion of the cycle, the

Figure 2. - Temperature conditions during typical engine cycle. (Dimensions are in inches.)

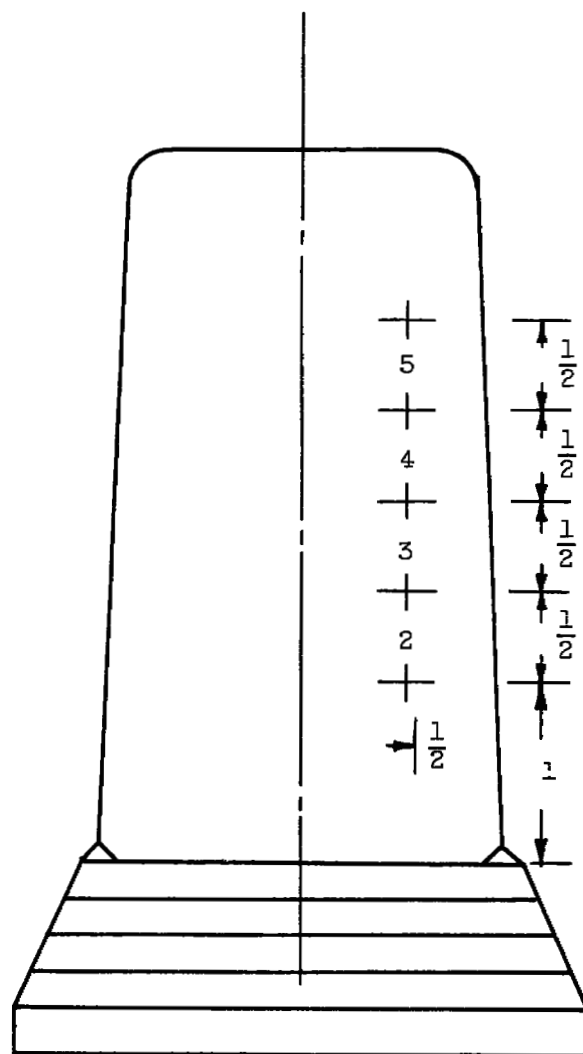
Two blades of each group were scribed in the manner shown in figure 3. At engine shutdown periods, measurements were made of blade elongation between the scribe marks using an optical extensometer.

Figure 3. - Location of scribe marks on convex side of turbine blades for use in measuring elongation. (Dimensions are in inches.)

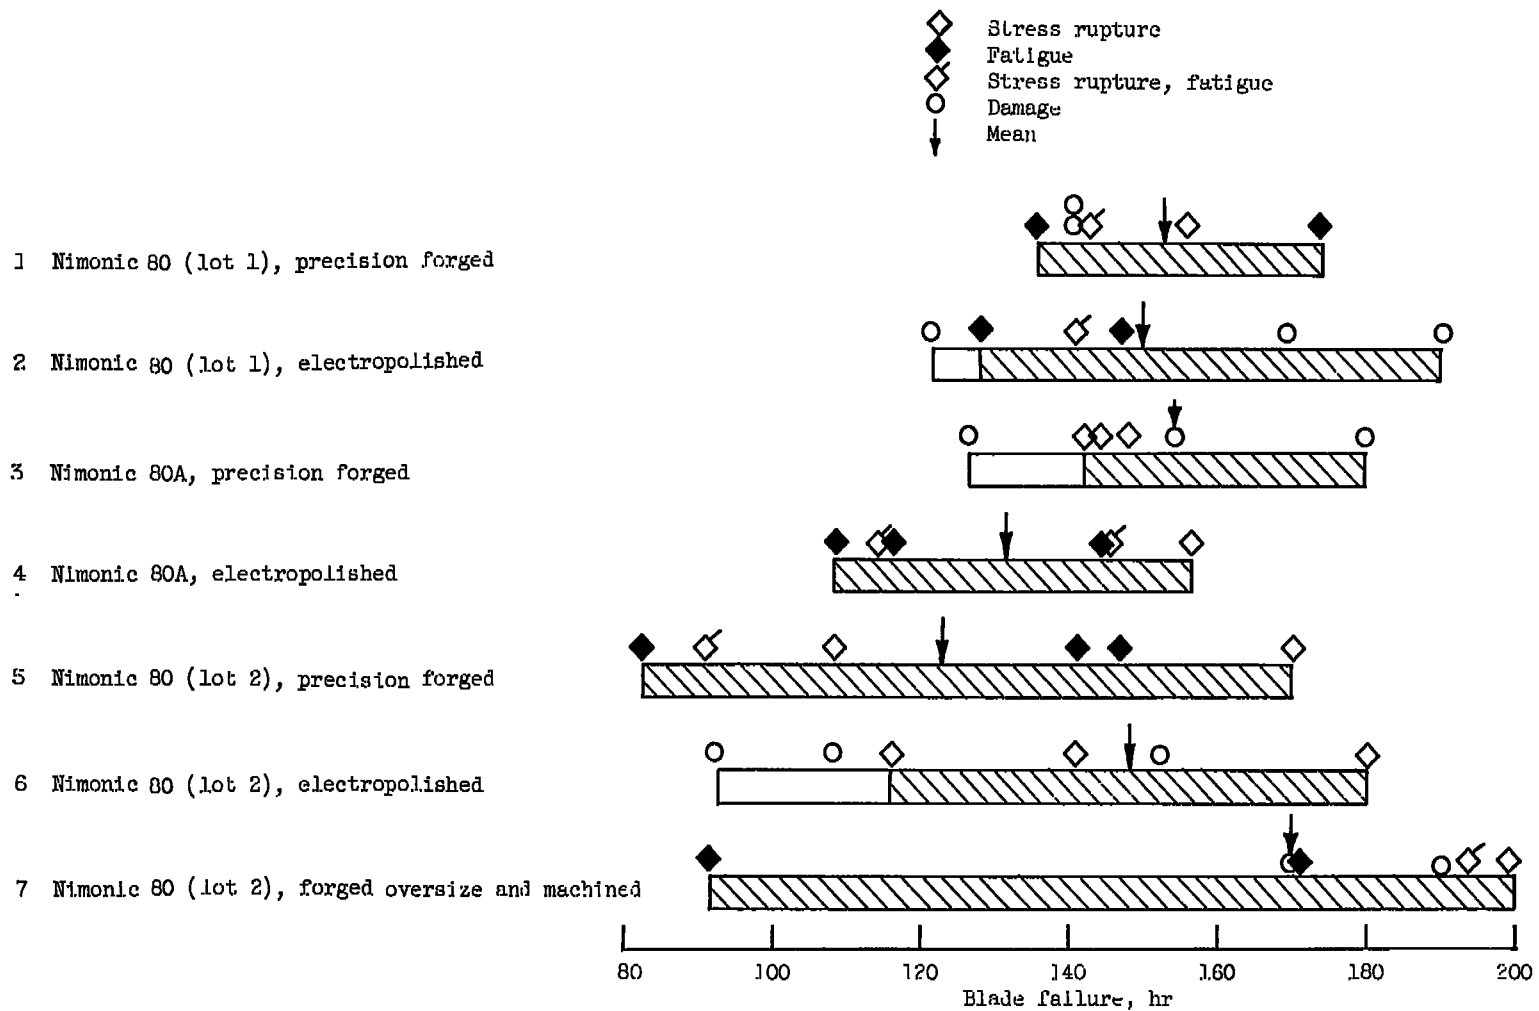
The results of the cyclic engine test are presented in table III and figure 4. On the basis of the total range of blade life and the mean blade life of each group shown in figure 4, no appreciable improvement resulted from electropolishing precision-forged blades or machining oversize forged blades. Furthermore, no appreciable difference in the engine performance of the various lots of blades resulted.

Figure 4. - Results of engine operation.

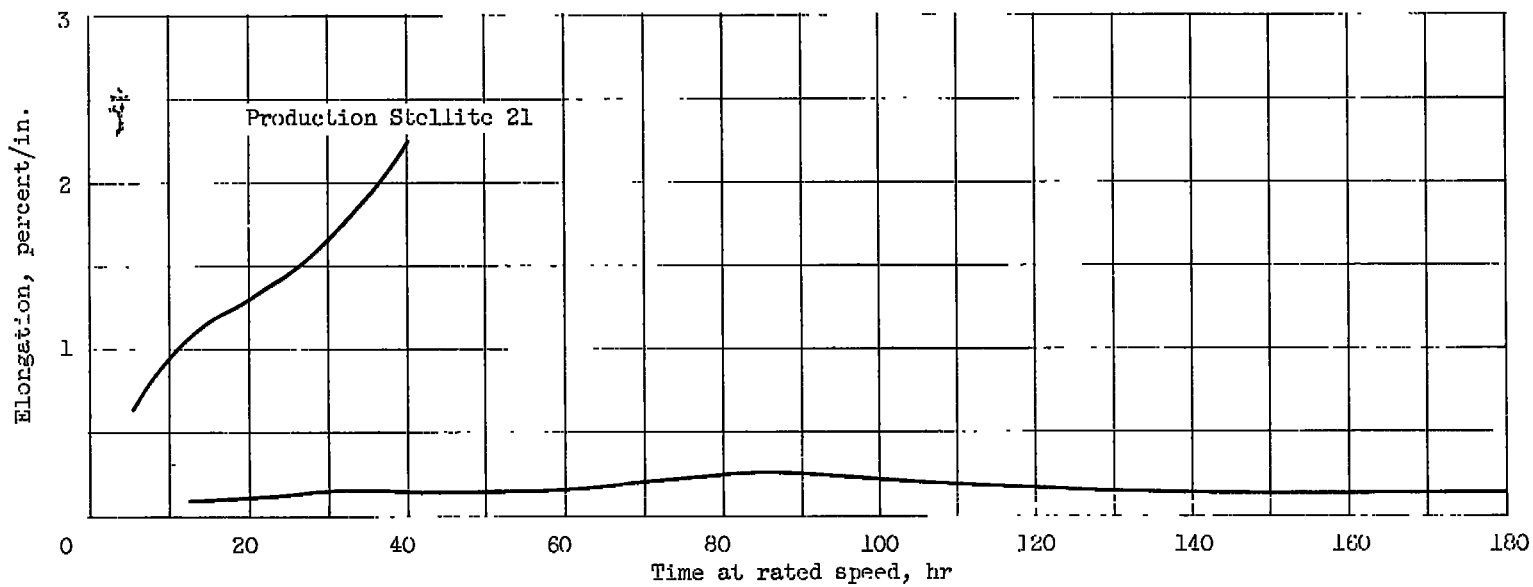
Blade elongation during engine operation ranged up to a maximum of 0.5 percent in the middle portion of the blades. A typical blade-elongation curve is presented in figure 5 along with a typical curve of Stellite 21 for comparison. The creep in the Nimonic blades is negligible.

Figure 5. - Typical elongation in zones 3 and 4 of Nimonic 80 alloy blades.
